BIG ELK LAKE DAM

(NDI I.D. PA-0056)

~~OWNER: MR. EDGAR SAKER~~  
Susquehanna River Basin, Elk Lake  
Stream, Susquehanna County, Pennsylvania  
PHASE I INSPECTION REPORT

PHASE I REPORT  
NATIONAL DAM INSPECTION PROGRAM

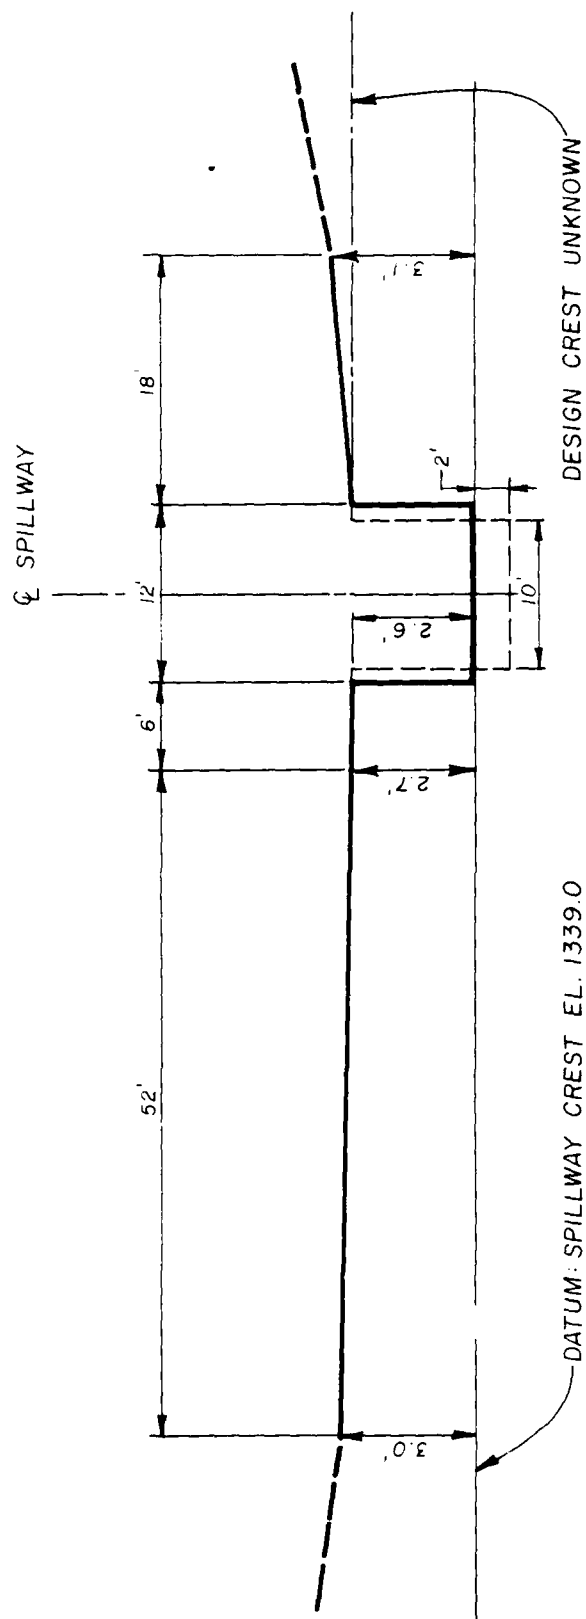
**DAM CREST PROFILE**  
(LOOKING DOWNSTREAM)

The crest of the dam was surveyed relative to the spillway crest elevation and it was found to be relatively uniform. The dam crest profile is illustrated in Plate 3.

d. Overtopping Potential. The 100-year flood was routed through the dam and it was found that the dam crest would be overtopped for a duration of 28.0 hours at a maximum depth of 1.9 feet over the dam crest.
